Manhole Inspection Summary

Manhole # S39G__105MH

Location Address: **866 E Lombard St**

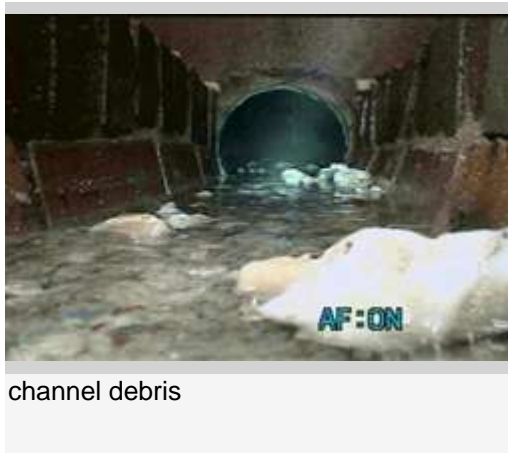
Defect 1

Condition: ☐ Sound ☐ Cracked ☐ Root Intrusion ☐ Deteriorated ☐ Leaks ☒ **Debris**

channel debris

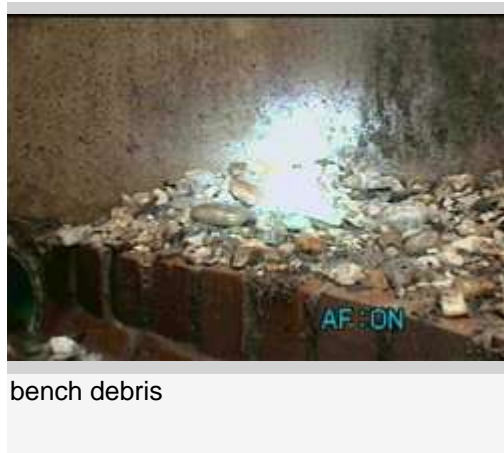
Defect 4

Condition: ☐ Sound ☐ Cracked ☐ Root Intrusion ☐ Deteriorated ☐ Leaks ☒ **Debris**

bench debris

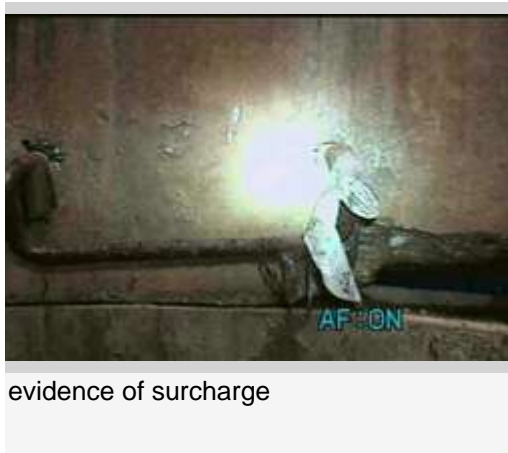
Defect 3

Surcharge ☒ **Evidence Of Surcharge** Depth: **9.** (ft.) ☐ Active Surcharge Present

evidence of surcharge

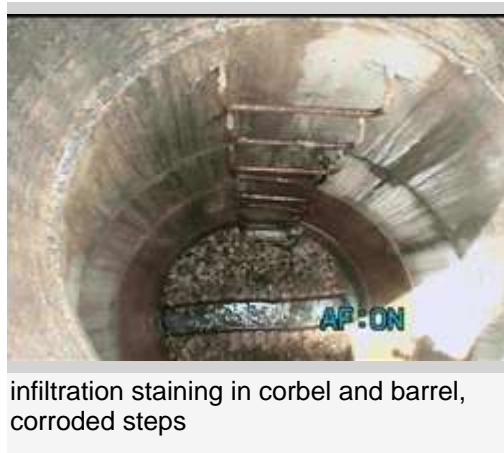
Defect 2

Infiltration: ☐ None ☒ **Joint** ☐ Cracks ☐ Mortar ☐ Roots ☐ Wall

Steps Count: **9** Missing: **0** ☒ **Corroded**

infiltration staining in corbel and barrel,
corroded steps
